1. REPORT DATE (DD-MM-YYYY)	2. REPORT TYPE	3. DATES COVERED (From - To)
06-02-2017	Final Report	Nov. 2013 - Dec. 2016
4. TITLE AND SUBTITLE		5a. CONTRACT NUMBER
Experimental Investigation Implosion of Composite Str	of Free Field and Shock-Initiated uctures	<b>5b. GRANT NUMBER</b> N00014-10-1-0662
•		5c. PROGRAM ELEMENT NUMBER
6. AUTHOR(S)		5d. PROJECT NUMBER
Arun Shukla		5e. TASK NUMBER
		5f. WORK UNIT NUMBER
7. PERFORMING ORGANIZATION NAME(	S) AND ADDRESS(ES)	8. PERFORMING ORGANIZATION REPORT NUMBER
University of Rhode Island		
70 Lower College Rd.		
Kingston, RI 02881-0811		4
9. SPONSORING / MONITORING AGENCY	NAME(S) AND ADDRESS(ES)	10. SPONSOR/MONITOR'S ACRONYM(S)
Office of Naval Research		
875 North Randolph St.		
Arlington, VA 22203-1995		11. SPONSOR/MONITOR'S REPORT NUMBER(S)
12. DISTRIBUTION / AVAILABILITY STATE	EMENT	L

A comprehensive series of experimental studies is performed to study the implosion behavior of a variety of different composite structures under varying loading conditions. Experiments are performed in a large pressure vessel designed to maintain constant hydrostatic pressure during collapse. 3D Digital Image Correlation (DIC) is calibrated for submerged str

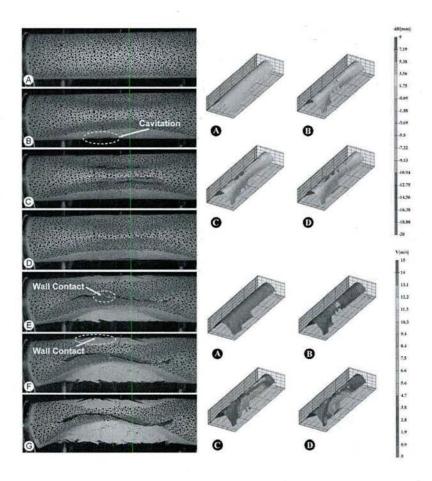
visible damage. At time B, a longitudinal crack is observed on the bottom visible lobe of the structure, pursued immediately by a small amount of cavitation on that surface. This is followed by an abrupt drop in local pressure, caused by increased acceleration due to the loss of structural stability in that region brought on by cracking. The local pressure continues to fall until it reaches a minimum at time C. At this instant, it is observed that surface cavitation has intensified, reflecting this drop in pressure. A sudden increase in velocity magnitude is also seen at time C, increasing from ~4m/s at time B to ~10m/s over a period of 0.5ms, demonstrating the sudden loss of stability brought on by longitudinal cracking. Following the minimum pressure, a sudden spike in pressure is seen at time D. This spike is relatively large, ~0.15MPa, and has not been observed in previous implosion studies on homogeneous materials. The cause of this peak can be found by comparing images at C and D. In image C, as previously discussed, the bubbles formed by surface cavitation are at their maximum size. In image D, all visible bubbles have vanished. Between these two images, the surface cavitation bubbles collapse inward upon themselves and the surface on which they reside. The collapse of such bubbles has been well documented as resulting in large pressure pulses [26], and is therefore the cause of the observed spike at time D in the local pressure trace. It should be noted that no DIC contours are available after time D, as large scale damage to the surface of the specimen caused destruction of the speckle pattern and subsequently loss of correlation.

Figure 6: High-speed photographs (left) and DIC contours of radial displacement (top-right) and velocity (bottom-right) for CT specimens

Near the end of the underpressure region of the pressure history, two small yet distinct peaks can be seen at times E and F. These peaks are analogous to those seen in the implosion of aluminum tubes [8,9] and are indicative of wall-to-wall contacts at the center of the structure. The reason that multiple wall contacts are seen in this case is that the structure buckles in a mode 3 shape, and the non-homogenous nature of the material may cause two lobes to contact slightly before the third makes contact. Looking at the corresponding images E and F, wall-to-wall contacts are indeed seen as indicated by arrows.

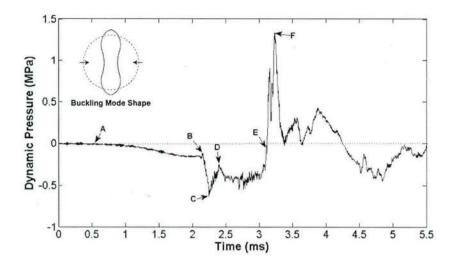
The smaller diameter filament-wound CTRD specimens at 1.60 MPa. Interestingly, both of these specimens appear to initiate a mode 3 collapse shape, then reduce to a mode 2 shape as the implosion progresses and the tube flattens. As with the larger specimens, the tubes return to a roughly cylindrical shape following depressurization. The averaged local pressure trace about the midspan of the specimen at a standoff distance of 48.3mm is shown in Figure 8, and high-speed images as well as DIC generated displacement and velocity contours corresponding to key points on the trace are seen in Figure 9.

Figure 8: Local pressure history and buckling mode shape about midspan of CTRD specimens

CTRD specimens also experience some initial quasi-static deformation, though it is significantly less than CT specimen, amounting to only -1.02mm (3% of tube radius). The reason for this difference is the increased structural rigidity of these specimens brought on by reduced diameter and increased thickness-to-radius ratio. The collapse and resulting local pressure history for CTRD specimens is quite similar to that of the larger diameter filament-wound tubes previously discussed. A relatively smooth drop in pressure is observed between times A and B (~1.5ms) as the tube begins to collapse in a mode 3 shape as seen in the corresponding high-speed images. Over this period, the tube is seen to be collapsing with a velocity of ~8.75 m/s in DIC contours, significantly faster than CT specimens. At time B in the pressure profile, a small sharp peak is seen followed by a rapid drop in pressure. Similar to CT specimens, this corresponds to the appearance of a longitudinal crack (see Figure 9.B) causing the loss of structural stability which in turn allows the speed of collapse to increase greatly. In fact, immediately after through-thickness cracking, at time C, a large region of significantly higher velocity, ~14 m/s, appears in the vicinity of the crack. This rapid increase in fluid velocity results in an equally rapid drop in

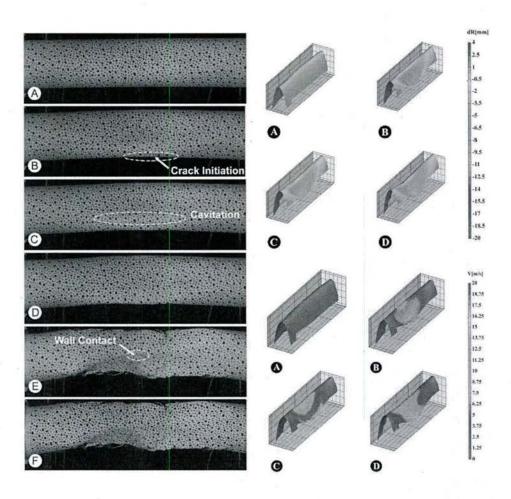
pressure, and the pressure continues to fall steeply to a distinct minimum at that time. At this point, the pressure at the surface of the structure has fallen low enough to cause cavitation, as highlighted in the corresponding image in Figure 9. At time D, the pressure rises to a relatively small peak. Examining high-speed images shows that cavitation bubbles have vanished at this time, indicating that this peak is a result of a pressure pulse emitted from the collapse of the bubbles. The underpressure region continues until time E when a sharp peak is observed. This peak corresponds to the wall-to-wall contact at the completion of the collapse, as previously discussed, and is shown in the matched high-speed photograph. As was the case with CT specimens, damage on the surface of the structure causes loss of DIC correlation after this time

Figure 9: High-speed photographs (left) and DIC contours of radial displacement (top-right) and velocity (bottom-right) for CTRD specimens

This wall-to-wall contact is followed by a high magnitude pressure pulse and a broad region of overpressure as the entirety of the structure collapses. At image F, the tube has fully collapsed circumferentially in a mode 2 shape and after this time the buckle propagates rapidly through the length of the structure.

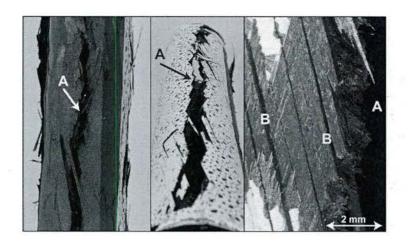
Post-mortem images of CTRD specimens are included in Figure 10. Much like the larger diameter CT specimens, longitudinal cracking, marked as "A" appears to be the chief mode of failure, however damage is considerable more severe for these tubes. It is seen in these images that through-thickness, longitudinal cracks have completely separated the structure. In addition, the damage appears somewhat less localized to the major cracks, implying a significantly more catastrophic collapse than for larger diameter specimens. Optical microscopic images of the fracture surface show a great deal of interfibrillar cracks branching off of the critical longitudinal cracks, marked as "B", showing these specimens exhibited more energy intensive damage and failure. As these specimens collapsed at a significantly higher pressure than the lager diameter CT specimens, more potential energy was available at the time of collapse. This increased energy resulted in a much more catastrophic collapse and caused the more severe state of damage observed in the post mortem photographs.

**Figure 10:** Post-mortem images of CTRD specimens showing: (A) through-thickness longitudinal cracking, and (B) interfibrillar cracking

An interesting feature of CTRD post-mortem specimens is the existence of three longitudinal cracks, spaced at approximately 120°, implying a mode 3 collapse though high-speed images showed a flattened mode 2 collapse shape. As previously mentioned, the collapse of these tubes initiated in a mode 3 shape, causing the formation of three buckle lobes. Longitudinal cracks formed in each of these lobes as in CT specimens, however the resulting loss of structural stiffness in this cased caused the reduction of the collapse shape to mode 2. In this way, these specimens were able to exhibit evidence of both mode 3 and mode 2 buckling.

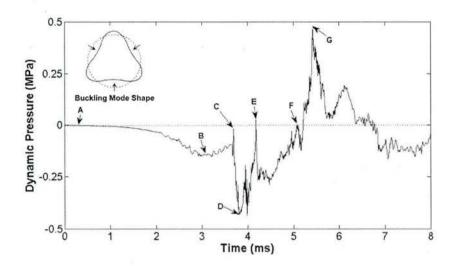
The RC specimens collapsed in a mode 3 buckling shape at 0.75 MPa. The averaged local pressure trace about the midspan of the specimen at a standoff distance of 40.6mm is shown in Figure 11, and high-speed images as well as DIC generated displacement and velocity contours corresponding to key points on the trace are seen in Figure 12. For these specimens, correlation is maintained nearly through the entirety of the collapse.

Figure 11: Local pressure history and buckling mode shape about midspan of RC specimens

RC tubes experience quasi-static ovalling of -2.61mm (7% of tube radius) prior to the dynamic implosion event. This is significantly less than seen in filament-wound tubes of the same diameter, mainly due to the enhanced directional stiffness of these specimens as significantly more fibers are oriented along the major axes of the tube. The collapse of these tubes show many similarities to the filament-wound specimens discussed previously. Initially, the local pressure decays rather smoothly up until time B as the structure deforms into a mode 3 shape. At time B, longitudinal cracks are seen to emerge on the apex of a visible buckling lobe, as indicated in the corresponding photograph. However, these cracks do not compromise the structural integrity of the tube significantly at that time as they are simply surface cracks that do not completely penetrate the walls of the tube. The local pressure then rises somewhat until a sharp peak is observed at time C. This corresponds with the opening of cracks as marked in image C in conjunction with the onset of cavitation on the surface of the structure. Following this occurrence, the pressure drops sharply to a minimum at time D. This implies that at time C, the cracks previously formed propagate through the thickness of the tube walls, causing a sudden

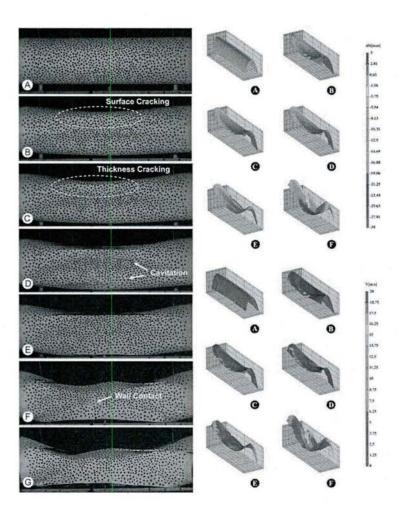
loss in stability and rapidly accelerating the collapse. This is reinforced by examining DIC contours at time D, where a region of high velocity (~14m/s) appears adjacent to the buckling lobe, increasing from a relatively moderate velocity of 5 m/s in the previous image at time C.

Figure 12: High-speed photographs (left) and DIC contours of radial displacement (top-right) and velocity (bottom-right) for RC specimens

The crack itself releases an acoustic pulse seen at time C and the rapid acceleration of the surrounding fluid manifests in the sharp drop in pressure observed. At time D where pressure is at a minimum, the cavitation bubbles which initiate at time C are seen to be at their maximum

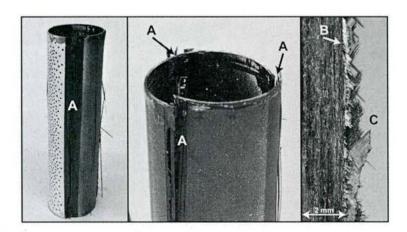
**Figure 13:** Post-mortem images of RC specimens showing: (A) through-thickness longitudinal cracking, (B) delamination of 0° fiber bundles, and (C) fractured fibers

Post-mortem images of RC specimens are included in Figure 13. Similar to the previous specimens, due to the mode 3 collapse shape, the most prominent damage feature is longitudinal cracking, marked as "A", with three through-thickness cracks located at 120° intervals about the circumference. Like CT tubes, this damage is fairly localized to said cracks, with only small amounts of circumferential cracking. However, unlike the previous two cases, there is also a good deal of delamination of tows in the outer longitudinal ply, marked as "B". Because these tows were parallel to the direction of the major cracks along their entire length, they simply separated from the laminate via matrix cracking rather than fracturing the actual fibers as in the case of angled plies. Optical microscopy of the fracture surface show that internal angle plies experience fiber fracture, marked as "C" parallel to the fiber angle of the outer ply, with relatively small amounts of fiber pull-out. This reinforces the assertion that cracking initiates in the outer ply in the weak interfibrillar region and retains its original orientation as it propagates through the thickness of the laminate.

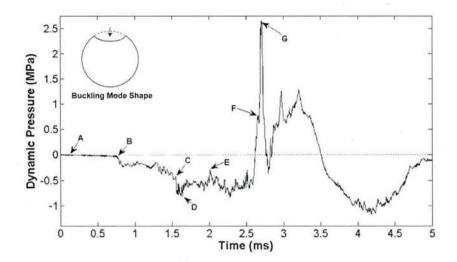
In both tests of BC tubes, the specimens fail very rapidly at 1.81 MPa, and in both cases, the collapse is so violent that the tube tears free of the sealing end caps and falls from the support structure. In these cases, the collapse mode is an imperfect mode 2 shape, with one wall drawn in toward the other, analogous to an indentation. The averaged local pressure trace about the midspan of the specimen at a standoff distance of 41.0mm is shown in Figure 14, and high-speed images as well as DIC generated displacement and velocity contours corresponding to key points on the trace are seen in Figure 15.

Figure 14: Local pressure history and buckling mode shape about midspan of BC specimens

Braided specimens show the least quasi-static ovalling of all 76.2mm diameter specimens, amounting to -1.39mm (2.6% of tube radius). This shows that braided tubes give the least "warning" before undergoing catastrophic failure. From time A to B, little change is noted in the pressure trace. Similarly, only a small degree of buckling is noted in the high-speed photographs as the tube begins to "oval" slightly. Likewise, very little change is seen in velocity and displacement contours between these times. Following time B, the collapse intensifies as the wall facing the cameras is drawn inward toward the center of the implodable. Pressure then drops fairly slowly until time C, at which point through-thickness cracks are seen to appear in the corresponding high-speed image. It is interesting to note that the structure does not buckle inward with a single smooth valley, but instead with two distinct local indentations as is highlighted by the displacement contour at time C. This phenomenon is a result of axial imperfections in the thickness of the tube walls. Some regions along the length axis of the specimen are somewhat thicker than others, and those regions act as ring stiffeners, inhibiting bucking at that point. This will in turn result in local buckling valleys to form on either side of

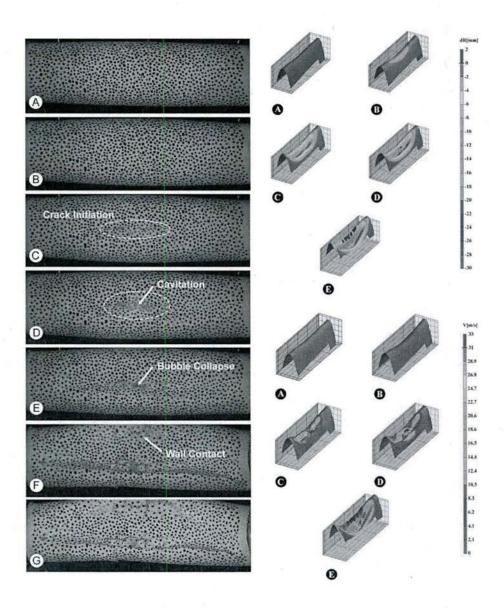
Figure 15: High-speed photographs (left) and DIC contours of radial displacement (top-right) and velocity (bottom-right) for BC specimens

The cracking results in a loss structural integrity, allowing the wall to accelerate rapidly inward and drop local pressure to a minimum at time D. Here only one larger buckling valley is seen, and the velocity across the surface has reached an apex at the center of the buckling valley of ~33 m/s. This high velocity causes a very significant drop in local pressure, explaining why the pressure reaches a minimum at this time. Also as a result, the cavitation bubbles initiated in the previous time have reached their maximum size as seen in image D. After reaching a critical size, these bubbles collapse in on themselves, resulting in the release of a pressure pulse observed at time E. Studying the image at this time, it is seen that the cavitation bubbles have collapsed completely in the region indicated by the arrow. The contours corresponding to time E show the further growth of the buckling shape, however due to cracking much data is lost especially at the center of the buckling valley, and after this time correlation is lost nearly completely.

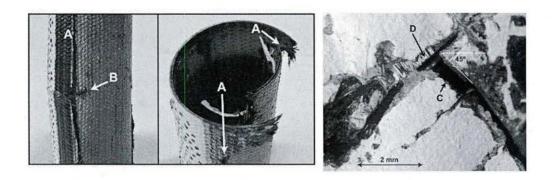
**Figure 16:** Post-mortem images of BC specimens showing: (A) longitudinal cracking, (B) circumferential cracking, (C) fractured matrix material, and (D) fractured fibers

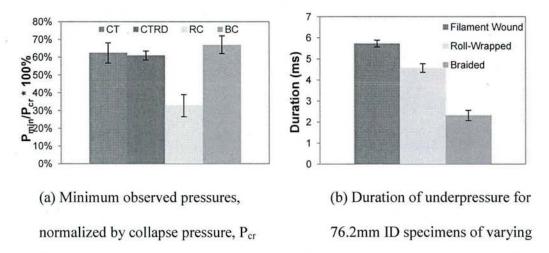
The minimum gage pressures of the local pressure history, normalized by hydrostatic collapse pressure, are compared for all specimens in Figure 17. Here it is useful to study minimum pressures in terms of dynamic pressure as a percentage of hydrostatic pressure as the collapse pressures varied between specimen types.

Figure 17: Quantitative parameters related to the underpressure region of the pressure history

It is first observed that all filament-wound and braided specimens reached approximately the same minimum pressure, experiencing a pressure drop of 65% of hydrostatic collapse pressure. In contrast, roll-wrapped tubes reached minimum pressures of 32% of hydrostatic pressure, half that of the other specimens. Because the majority of reinforcements are oriented along the length axis of the roll-wrapped specimens, they are less able to resist the collapse of the structure. This caused less energy to be dissipated in damage during collapse, allowing for greater collapse speed and consequently lower minimum pressure. This also explains why the intensity of cavitation is greatest for roll-wrapped tubes, as the lower pressure created a more favorable environment for this phenomenon.

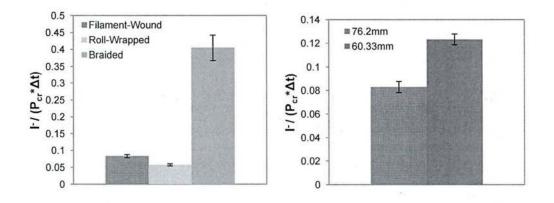
**Figure 18:** Normalized impulse for 76.2mm tubes of different reinforcement (left) and for filament-wound tubes of varying diameters (right)

The normalized impulse, as previously defined, delivered in the collapse of specimens with varying reinforcement architecture is compared in Figure 18(a). This plot shows that the pressure wave released in the collapse of braided carbon composite tubes possesses a drastically higher impulse than either filament-wound or roll-wrapped tubes. The reason for this is believed to be the stiffening followed by rapid, brittle failure of braided reinforcements as previously discussed. This allows for a greater and more rapid change in momentum to be imparted on the surrounding fluid, resulting in a pressure pulse with greater impulse.

Figure 18(b) compares the normalized impulse measured in the collapse of filament-wound tubes with different diameters. Here it is noted that the normalized impulse for the smaller diameter specimens is 50% greater than that of larger diameter specimens. This difference is likely due to the change in buckling mode shape brought on by the reduction of diameter. This allowed for a significantly greater collapse speed and extent of collapse resulting in greater momentum change in the surrounding fluid and, consequently, a greater magnitude of impulse.

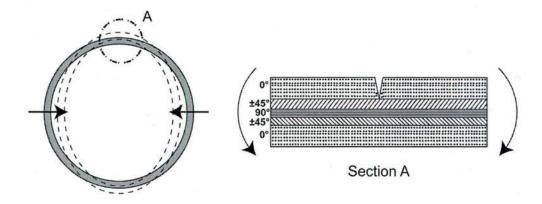
Figure 20: Growth of through-thickness crack in layered composite tubes

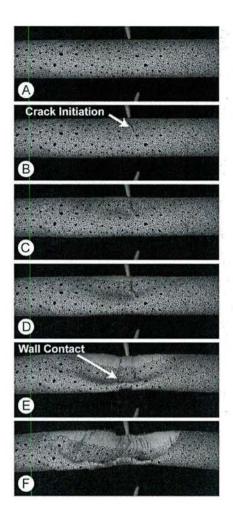
Fig. 6: High-speed photographs of key events for RT specimens

This new rate of pressure decay is maintained fairly constant until time D where the pressure is seen to drop quite suddenly. The photograph at this time shows that the dimple formed previously has grown significantly, and that additional fiber/matrix debonding is apparent on the specimen surface. This accumulated damage effectively reduces the stiffness and structural integrity of the tube, allowing for more rapid deformation and as a result steeper pressure drops. DIC contours show an intensification of both radial displacement and collapse velocity in the region of the observed dimple. The displacement and velocity are quite high at this time, 18mm

After this time, pressure continues to decay until a minimum value is reached. Shortly thereafter, a distinct, fairly small peak is observed at time E as pressure steeply rises. This peak is consistent with observations on the implosion of aluminum tubes [8-10] and represents initial contact of the walls of the structure. This is confirmed using high-speed photography, as the tube is seen to

make wall contact at that time in the location indicated by the white arrow. Pressure continues to rise until a maximum is reached at time F. The image at this time shows the propagation of the wall contact both circumferentially as well as axially. This peak is followed by a broad overpressure region as the collapse continues to propagate through the length of the specimen, after which the pressure returns to oscillate about the hydrostatic value.

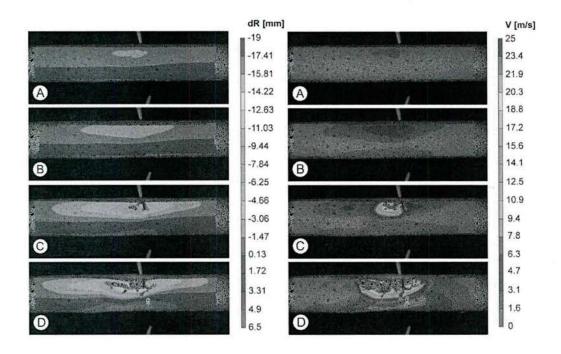
Prior to the dynamic collapse event, these specimens begin to oval significantly in a quasi-static manner. The DIC displacement contour shows a maximum radial deflection of -3.9mm (13.6%)

of specimen radius) at time A, indicating that this initial slow ovalling is quite significant for these tubes. From time A to B, DIC contours reflect the observed smooth deformation with relatively low radial displacement and velocity at time B. The unstable collapse appears to initiate at this time, where a steady drop in pressure is seen marking the beginning of the underpressure region of the pressure history. Examining the corresponding high-speed photograph, it is observed that damage also initiates at this time as indicated by the white arrow. This damage comes in the form of interfibrillar cracking/debonding, which will come to dominate the damage behavior of these materials. Pressure decays steadily until time C where the rate of decay increases suggesting an intensification of the collapse. The matched image in Fig. 6 shows the appearance of a dimple near the initiation of collapse, characteristic of the mode 2 buckling shape. The contours at time C also clearly show the dimple developed in the midspan of the specimen at that time. This region shows highly localized displacement of -12mm and much higher velocity of 18m/s, while the area outside of the dimple is largely unchanged from the previous key point. This shows that in the initial stages, this instability is a highly localized phenomenon.

and 20m/s respectively, however they are still localized to the small region of the dimple, while the rest of the structure maintains a near zero velocity. This rapid increase in displacement and velocity explains the further change in slope of the pressure decay as the collapse further hastens. After this time, image correlation is lost completely due to the destruction of the speckle pattern on the surface of the specimen. The beginning of this destruction can be seen in the contours at times C and D as increasingly large regions are devoid of data. It should be noted that due to this loss in DIC data, the maximum velocity prior to wall contact is not captured.

Fig. 7: DIC contours of radial displacement (left) and velocity (right) for RT specimens

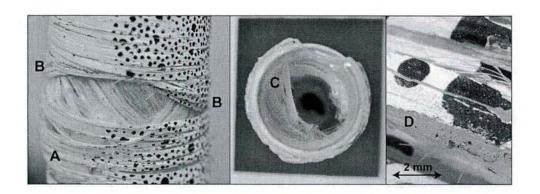
Fig. 8: Post-mortem images for glass/PE specimens, showing (A) matrix cracking, (B) delamination of outer hoop ply, (C) delamination of inner helical ply, and (D) long pulled-out glass fibers

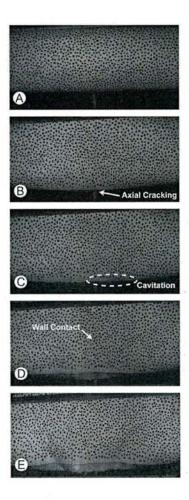
Fig. 10: High-speed photographs of key events for GT specimens

After time B, a more abrupt drop in pressure is observed. This is a result of longitudinal cracks that form along the apexes of the buckle lobes, causing a more abrupt increase in velocity and drop in pressure in the vicinity of the cracks due to a loss of structural integrity. At time C, the pressure at the surface of the structure drops low enough to initiate cavitation bubbles(see high speed image in Fig. 10), which grow to a critical size and then collapse on themselves. It is well known that the collapse of cavitation bubbles against a surface results in the release of very peaky pressure waves [28], and the superposition of these waves with the underpressure region results in their observed "peaky" period between times B and D. At time D, a very sharp spike is seen in the local pressure trace and wall-to-wall contact is observed in the region indicated by the arrow in the matched high-speed photograph. Wall contact is confirmed by examining the DIC velocity contour at this time which shows a small region of zero velocity at the center of the midspan. This point contact results in the release of the acoustic pressure spike recorded at time D. Additionally, the displacement contour at that time shows a maximum radial displacement of -49.4mm, which is quite close to the inner radius of the structure of 50.8mm. The maximum structural velocity prior to wall contact is measured by DIC as 18 m/s.

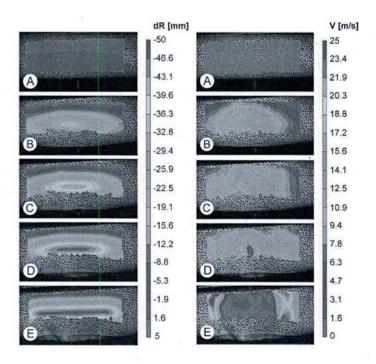
As is the case with the smaller RT tubes, the larger diameter GT specimens experience a significant amount of gradual ovalling prior to dynamic collapse. The DIC displacement contour shows a maximum radial deflection of -4.1mm (8.1% of specimen radius) at time A, similar in magnitude to that seen in the smaller specimens. After the dynamic collapse initiates, a rather smooth and gradual decay in pressure is observed between times A and B as the structure deforms in on itself without noticeable damage on the surface. DIC contours at time B indicate that over the course of this smooth deformation, large displacements of up to 36mm are achieved and the structure accelerates to a velocity of approximately 17m/s.

Fig. 11: DIC contours of radial displacement (left) and velocity (right) for GT specimens

Following wall contact, pressure rises rapidly to a maximum at time E as a result of the sudden momentum change imparted to surrounding fluid. DIC displacement and velocity contours show that the midspan of the specimen has flattened completely, and this buckle begins to propagate axially. This is evidenced by the expanded area of zero velocity combined with the greater region of near 50mm radial displacement. An interesting observation at this time is the development of a "buckle front", or a region of high velocity (~25m/s) immediately ahead of the collapsed, zero velocity zone. This corroborates with previous buckling experiments performed on long pipes which showed the propagation velocity of the buckle is significantly greater than the initial radial collapse velocity attained in the formation of the buckle [29]. After time E, the buckle shape continues to propagate through the length of the structure and pressure measurements are dominated by reflections from the tank boundaries.

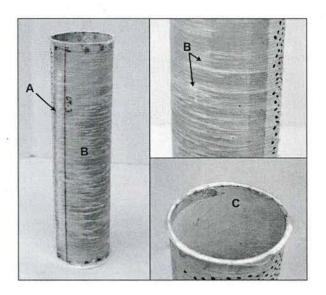
Fig. 12: Post-mortem images of GT specimens, showing (A) longitudinal cracking, (B) internal delamination, and (C) matrix cracking in the innermost ply

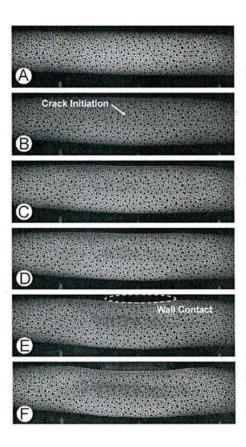
An amount of initial ovalling did occur in these specimens, although it is considerably less than either filament-wound specimen. The DIC displacement contour records a maximum deflection of -1.3mm (4.3% of specimen radius) prior to the implosion event. The dynamic collapse begins with a relatively slow decay in pressure from time A to time B, lasting ~2.25ms. This is much longer than the initial gradual decay seen in RT tubes, which lasted ~1ms before intensifying. At

time B, a slight recovery in pressure is seen followed by a very sharp drop to a minimum at time C. This is accompanied by the initiation of longitudinal cracking at the location indicated in the matched image. This suggests a very sudden loss in structural stability occurs at time B, resulting in the rapid acceleration of the structure and, consequently, an equally rapid drop in pressure. The velocity contour at this time displays a highly localized region of high velocity (11 m/s) appearing in the vicinity of that crack, confirming this hypothesis. The underpressure region continues until time E where a distinct peak is observed followed by a rapid increase in pressure, indicating wall contact. This is confirmed by examining the corresponding high speed image in which contact is observed in the marked region.

Fig. 14: High-speed photographs of key events for BG specimens

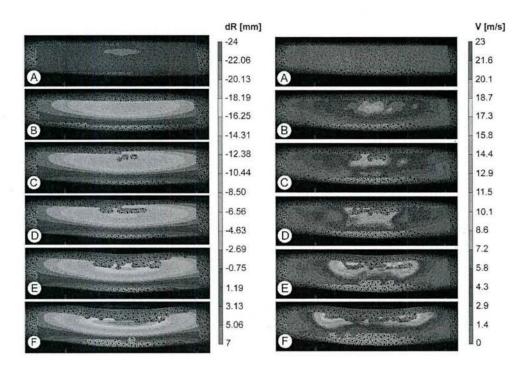
DIC contours at this time show the velocity at the nadir of the buckle valley suddenly drops and higher velocity regions are seen to either side of this point. This further reinforces the previous observation of wall contact at this time as deformation will halt wherever contact is made. However, due to the orientation of the buckle shape along with some loss of correlation from damage, the actual zero velocity region as well as the maximum collapse velocity are not captured. The high velocity regions to either side of the arrested area indicate the beginning of axial propagation of the buckle shape. After wall contact is made the high magnitude pressure pulse typical of the implosion arrives at time F. DIC contours show that axial propagation continues through time F where high velocity regions progress further away from the initial contact point and the area of near-zero velocity expands. After time F, extensive damage caused complete loss of useful data capture as the speckle pattern is critically obscured. It is interesting to note that as the buckle propagates axially, the magnitude of the high velocity regions appear to increase, reaching a maximum of 23 m/s before total loss of correlation. This is consistent with observations made on the buckling of the larger diameter GT specimens discussed previously.

Fig. 15: DIC contours of radial displacement (left) and velocity (right) for BG specimens

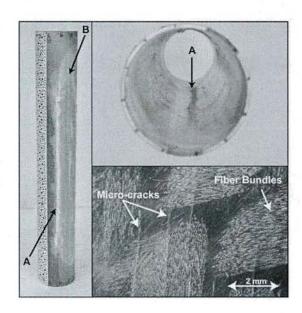
Fig. 16: Post-mortem images of BG specimens, showing (A) longitudinal cracking, and (B) internal delamination

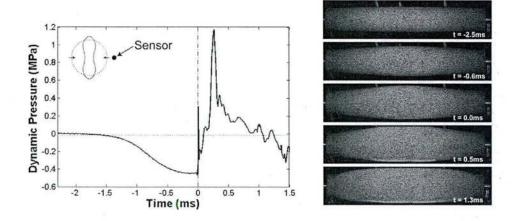
**Figure 2:** Representative pressure data and high-speed photographs recorded in the implosion of aluminum tubes

The pressure history measured for these specimens is quite consistent with reports of previous studies [2,9,10]. At the start of the collapse, the local pressure decays smoothly to a minimum just prior to t=0.00ms. This corresponds to an acceleration of the center of the tube to a maximum velocity of 20 m/s, as shown by DIC contours. At t=0.00ms, contact initiates between opposing walls of the tube, shown by the sudden drop in wall velocity at the center of the tube. This is accompanied by a very sharp spike in the local pressure at this time, indicating the acoustic pulse released due to wall contact. A second acoustic spike is observed as another wall contact is made when the buckle propagated circumferentially. Shortly thereafter, a large spike in pressure is observed with considerable impulse. This pulse is caused by the change in momentum of the surrounding fluid, which accelerated inward along with the walls of the structure. Following this pulse is a lower magnitude pressure tail that corresponds to the axial propagation of the buckle through the length of the tube, as seen in the displacement and velocity contours.

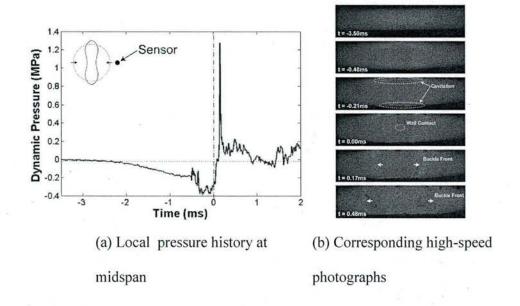
**Figure 4:** Representative pressure data and high-speed photographs recorded in the implosion of carbon/epoxy tubes.

Initially, the instability is characterized by a smooth and gradual decay in pressure up to t=-0.5ms. At this time, a distinct spike in pressure is recorded followed by a sharp drop to a minimum of -0.4 MPa. This spike is a result of longitudinal cracks that initiate at the apexes of the two buckling lobes, releasing an acoustic pulse. This cracking causes a sudden and severe loss of structural stability, allowing the tube walls to accelerate and, consequently, causing a more rapid drop in pressure. The remainder of the underpressure region sustains a minimum pressure, similar to observations made in the implosion of brittle glass tubes by Turner [25]. The drop in pressure seen in this region is sufficient to initiate cavitation near the apexes of the buckle lobes, as highlighted in Figure 4 at t=-0.21ms. This phenomenon leads to the formation of cavitation bubbles. These bubbles grow to a critical size and then collapse upon themselves, releasing acoustic pressure pulses upon collapse in the near field which are recorded as minor pressure spikes observed between t=-0.48ms and t=0.00ms.

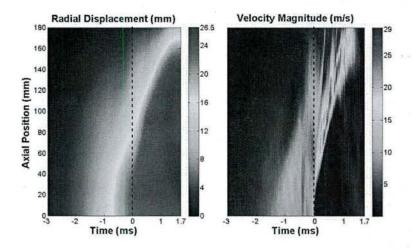
**Figure 5:** DIC contours of displacement and velocity across the length of carbon/epoxy specimens. Data is extracted from the dotted line shown in the image

Wall-to-wall contact occurs at t = 0.00ms in the location indicated in the matched high-speed photograph. The occurrence of wall contact is confirmed by the DIC generated velocity contour at that time which shows zero velocity at the center of the specimen. The maximum velocity recorded just prior to wall contact is 16 m/s, which represents the maximum wall velocity in the radial direction.

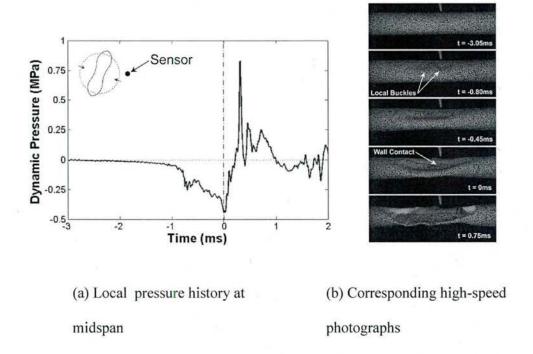
Filament-wound glass fiber specimens fail at 2.05 MPa in a mode 2 buckling shape. The tubes flatten completely during the dynamic failure event, but are seen to rebound to a nearly circular shape following the depressurization. The local pressure history measured about the midspan of these specimens and high-speed photographs are included in Figure 7. DIC generated contours of radial displacement and velocity along the length of the tube are plotted in Figure 8. The DIC contours show the displacement and velocity extracted across a line along the length axis of the tube as shown in the figure.

Figure 7: Representative pressure data and high-speed photographs recorded in the implosion of glass/PE tubes

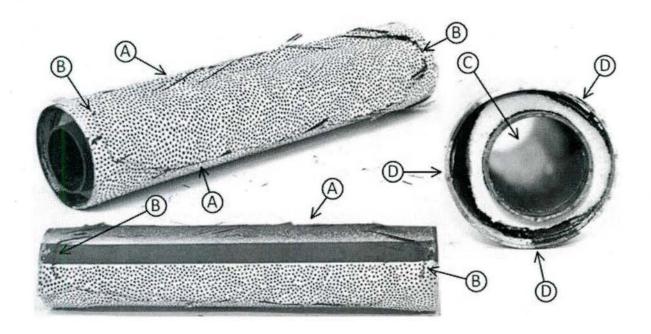
Figure 11: H35 core post-mortem specimen photographs; (top left) isometric view; (bottom left) top view; (right) right view; (A) longitudinal through-thickness cracks in outer tube, corresponding to mode 3 buckling shape; (B) circumferential through-thickness cracks from endcaps; (C) Intact inner tube; (D) foam core crushing in mode 3 shape.

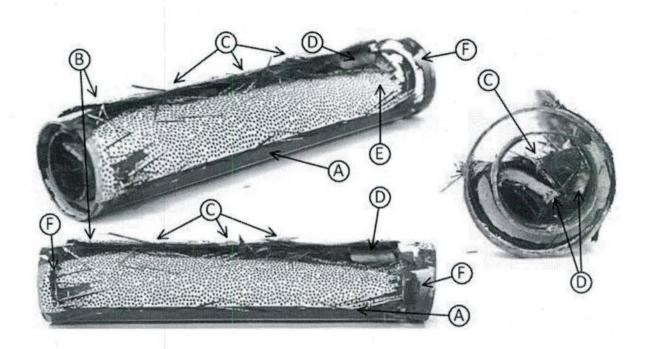
Figure 12: H100 core post-mortem specimen photographs; (top left) isometric view; (bottom left) front view; (right) right view; (A) longitudinal through-thickness cracks in outer tube, corresponding to mode 3 buckling shape; (B) Edge of through thickness tear, where the outer tube has completely cracked and folded under itself; (C) Delamination at tear edge; (D) Torn foam core; (E) Incomplete elastic recovery; (F) circumferential through-thickness cracking from endcap shear.

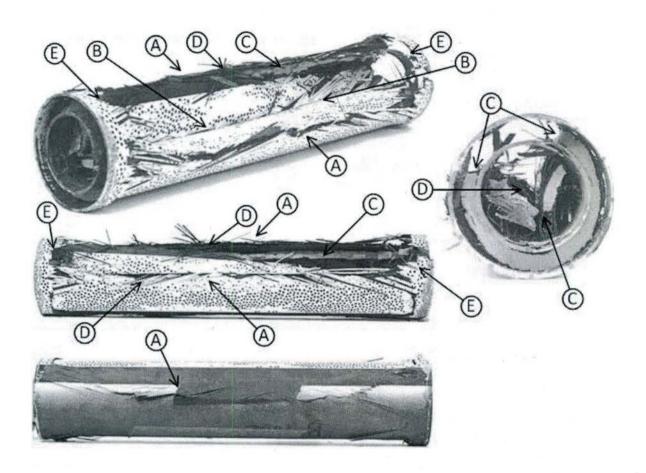
Figure 13: H80 core specimen post-mortem photographs; (top left) isometric view; (center left) front view; (bottom left) bottom view; (right) right view; (A) longitudinal cracking corresponding to lobes of mode 3 buckling shape; (B) center of fold where buckling directions of tubes aligned; (C) Through-thickness tearing of both the tubes and core corresponding to collapse of the inner tube; (D) Delamination and fiber pullout along tear edges; (E) Circumferential cracking from endcaps
